INDIVIDUAL INVENTORY FORM**NHDHR INVENTORY NUMBER: CON0180****Name, Location, Ownership**

1. Historic name: _____
2. District or area: Oak Hill Agricultural Neighborhood
3. Street and number: 131 Oak Hill Rd.
4. City or town: Concord
5. County: Merrimack
6. Current owner: Virginia Green

NHDHR INVENTORY NUMBER: CON0180

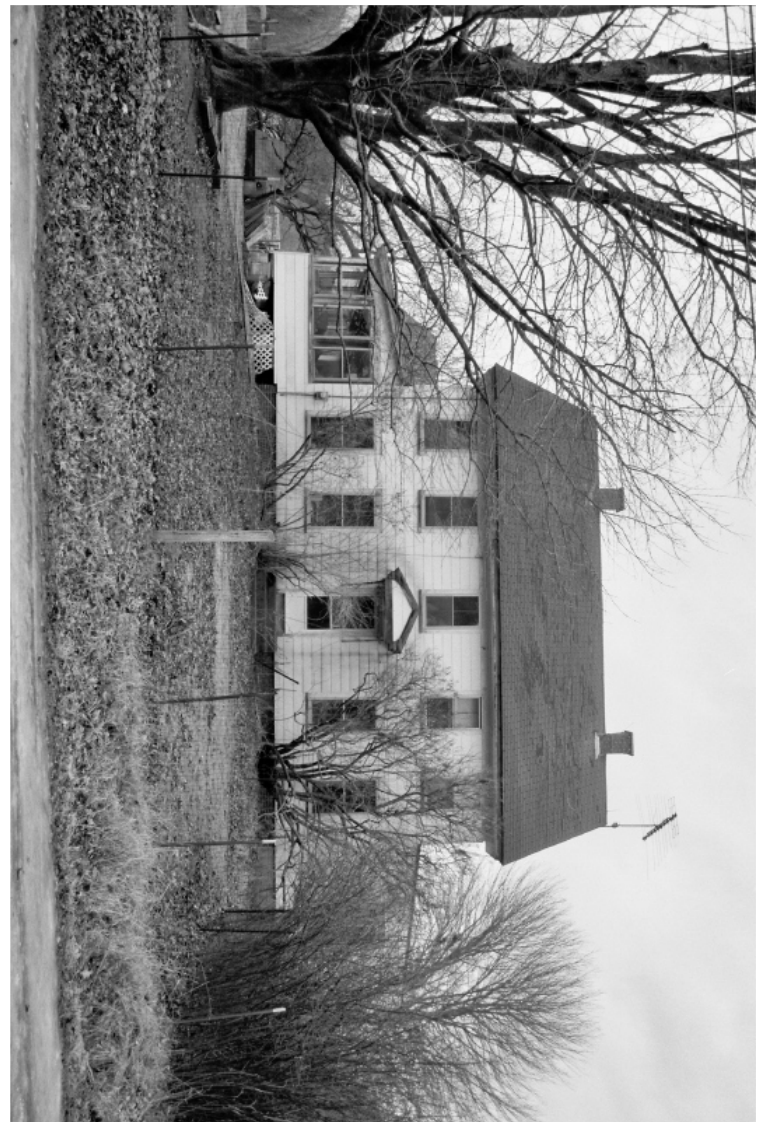
| 35. Photo #1 | 36. Date <u>Fall 2008</u> |

**Description:** Farmhouse, front (southeast) elevation

House (ca. 1900): This sits on the foundation of a pre-1858 house that burned. It is a 2 ½ story, 5x3 bay building with asbestos shingle siding, flat trim, and cornice returns. The front entrance is sheltered with a gabled door hood on stick brackets.

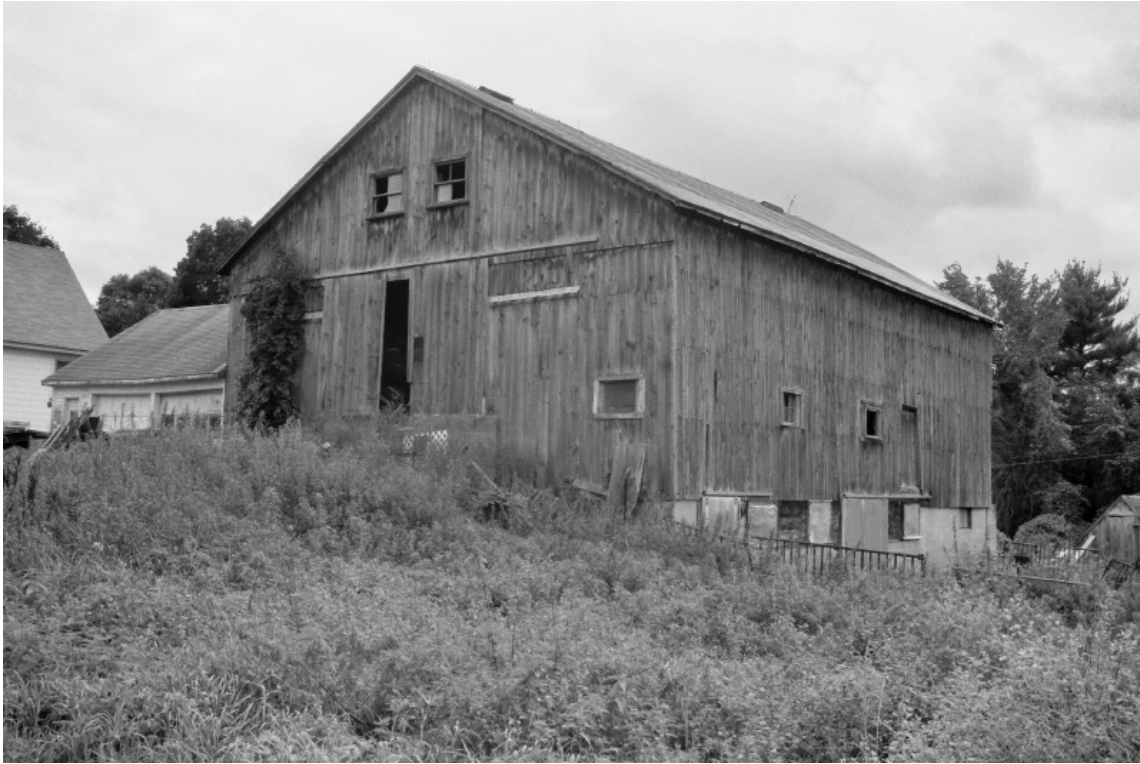
Photo 2 description: Front (northeast) & northwest elevations of barn. Garage is to left of barn.
Roll: 4 Frame: 17 Direction: S

Barn (ca. 1855-75): According to the owner, the barn was moved here after the original farm buildings burned ca. 1900. It is a gable-front, five-bay, timber-frame structure. The roof frame has common rafters and horizontal sheathing. Horse stalls occupy the northwest bays. A hay fork survives near the ridge.

The main doors are rolling and made of vertical boards. Exterior sheathing is vertical boards. Stall windows puncture the northwest wall. The barn was originally at grade (note door on northwest elevation). When it was moved here, it was sited to make the cellar accessible; in the 1960s, the cellar was enclosed with poured concrete.

Garage (ca. early 20th c.): This one-story, side-gabled structure on a concrete foundation is appended to the southeast wall of the barn. Walls are covered with clapboards. Two vehicular bays with overhead doors are on the front (northeast) wall.

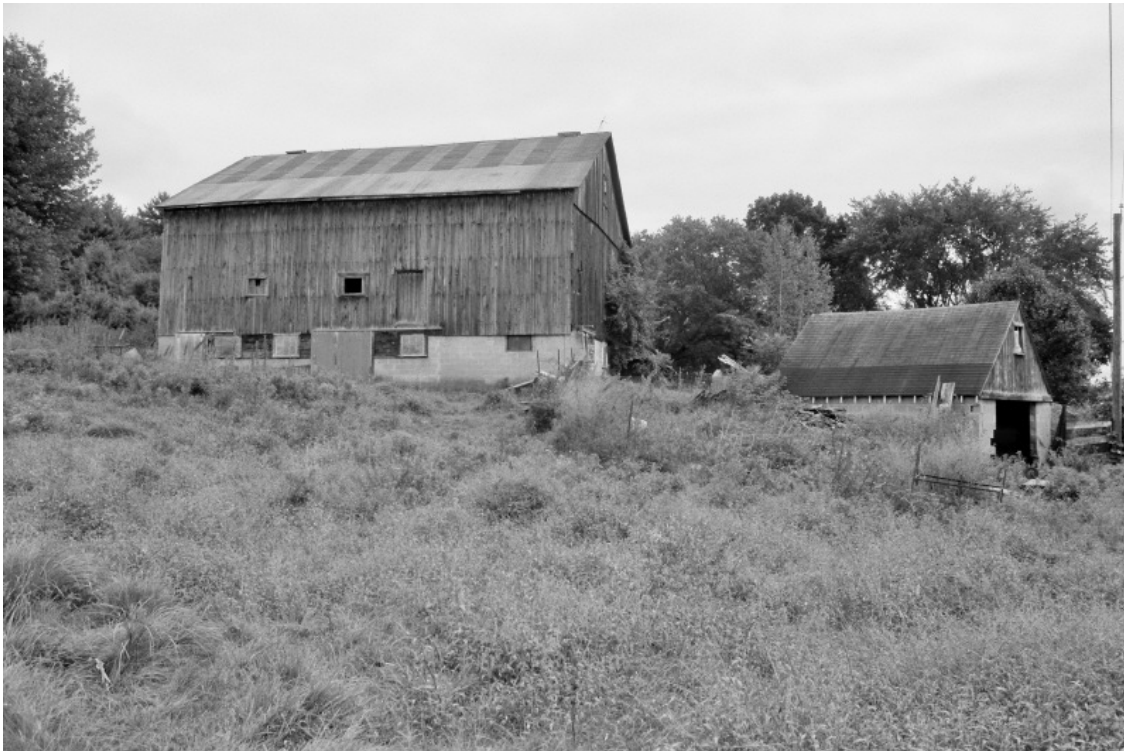
Photo 3 description: Northwest & rear (southwest) elevations of barn. Shed is to right.
Roll: 4 Frame: 15 Direction: E

Shed (1960s): Located behind the barn, the shed was built for manure storage, but now serves as an animal shelter. It sits on concrete block and has a gambrel roof.

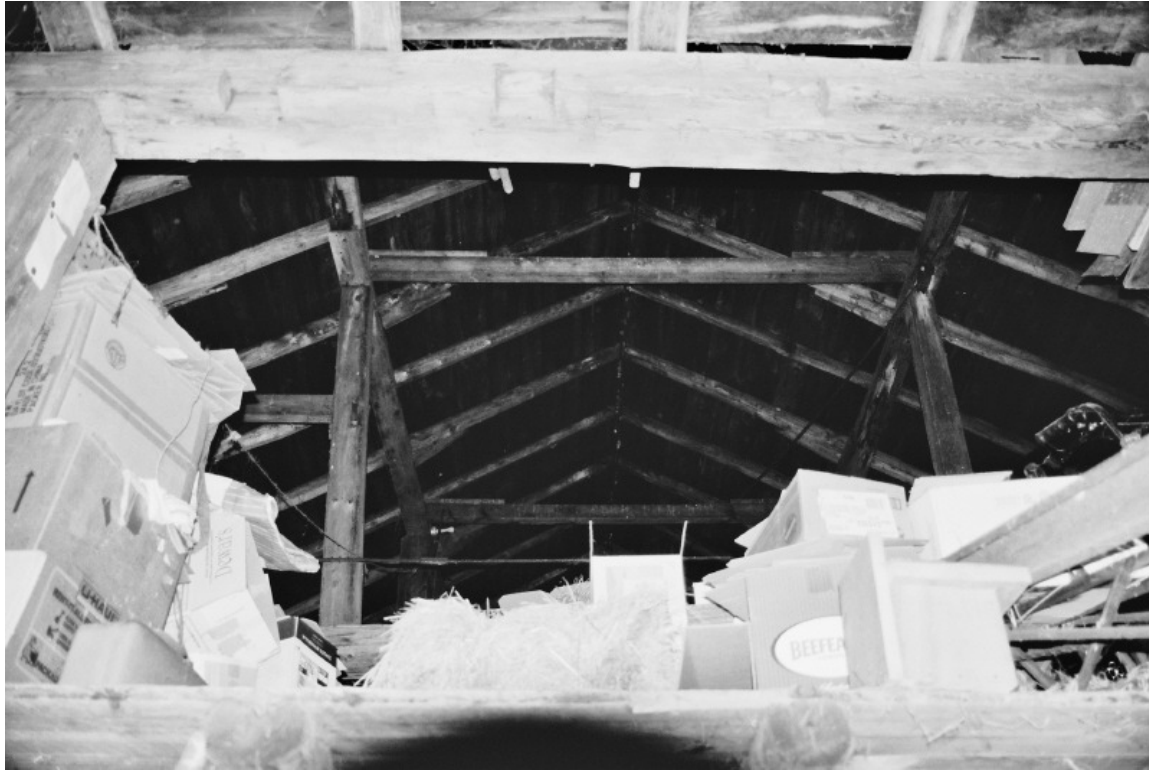
Photo 4 description: Interior frame of barn
Roll: 4 Frame: 14 Direction: SW

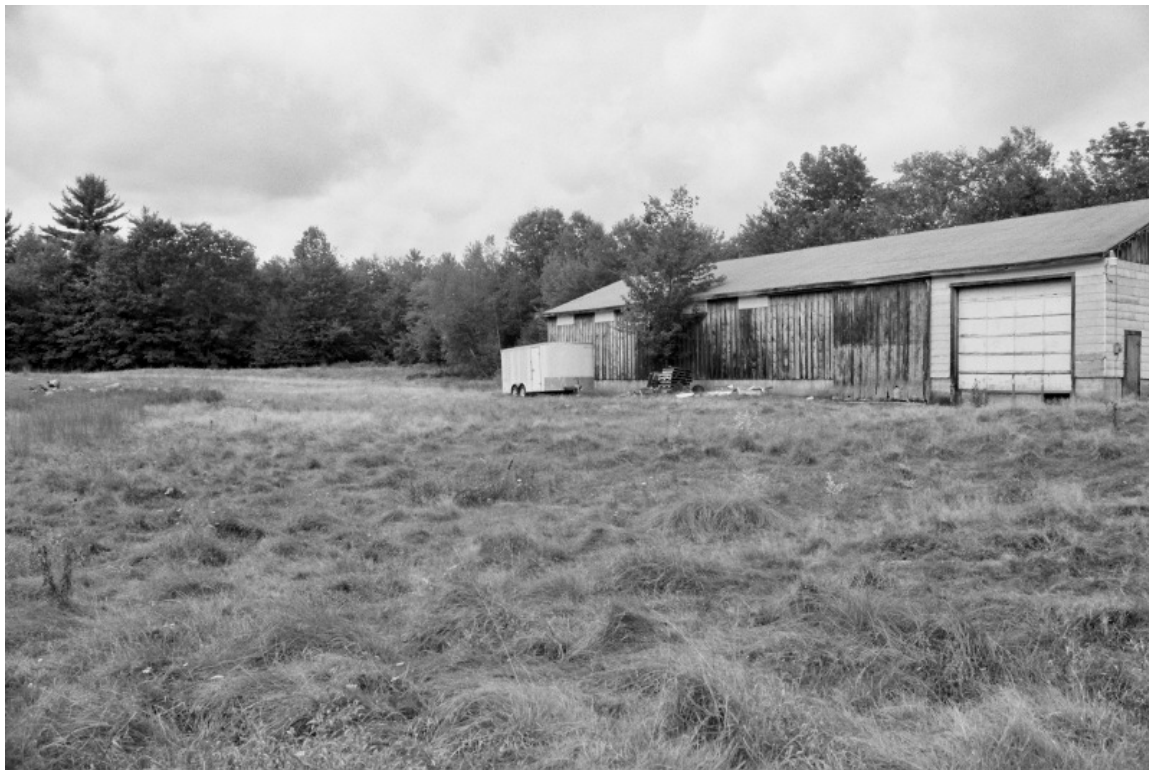
Photo 5 description: Late 1970s barn in hayfield
Roll: 4 Frame: 16 Direction: W

Shop/storage shed (late 1970s): This is located some distance behind (northwest) of the other outbuildings, at the edge of a former hayfield (now pasture) and backing up to woods. It is a one-story, side-gable, lengthy structure on concrete and primarily vertical-board siding.
